Subject: Letter about BackHome microchips

Letter regarding non-scanning BackHome BioTec
and BioGlass microchips.

Monday, 8th January 2018

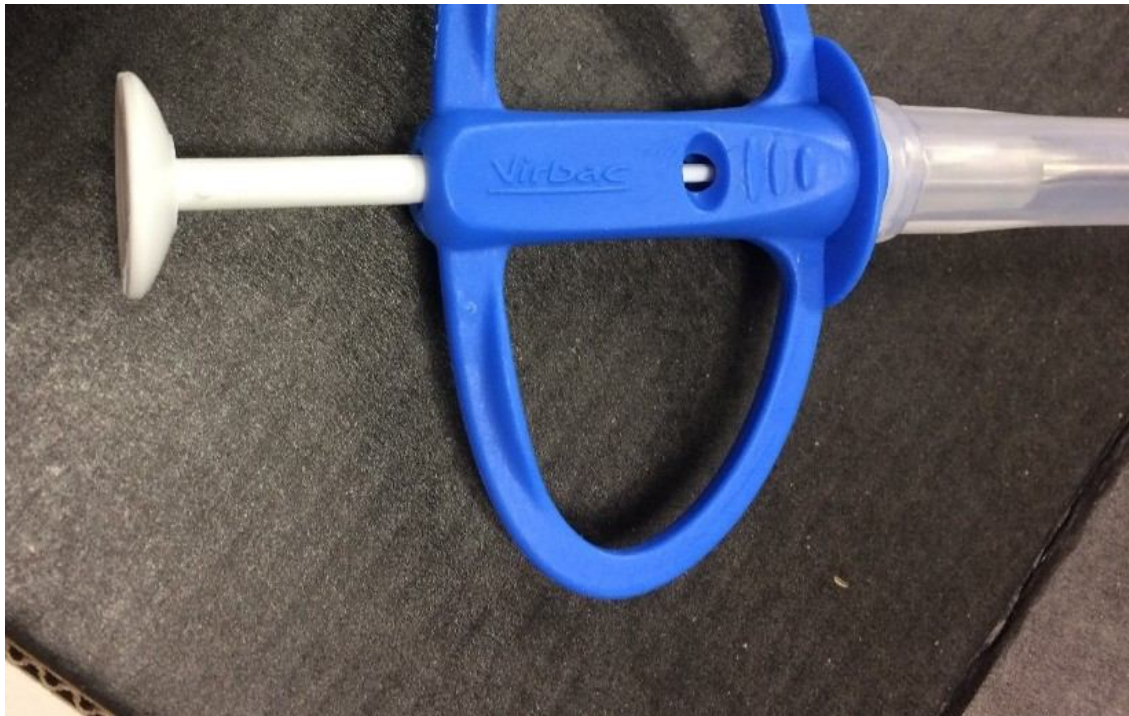
Here the plunger is extended and the indicator window is white.

The BackHome BioGlass applicator has an indicator window where a red line will appear when the plunger has been depressed correctly. This clicks home which prevents the stylet from backing out to help correctly place the microchip implant.

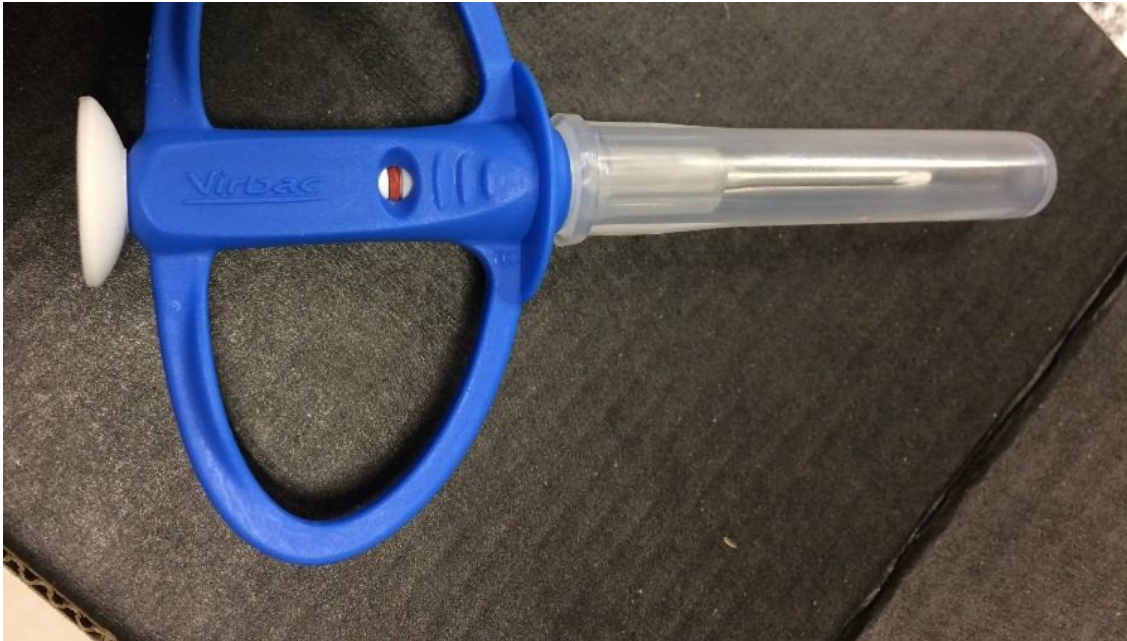
Now that the plunger is depressed the red line can be seen in the indicator window. Under the cap, the white stylet can be seen at the tip of the needle and the ejected microchip is loose inside the cap.

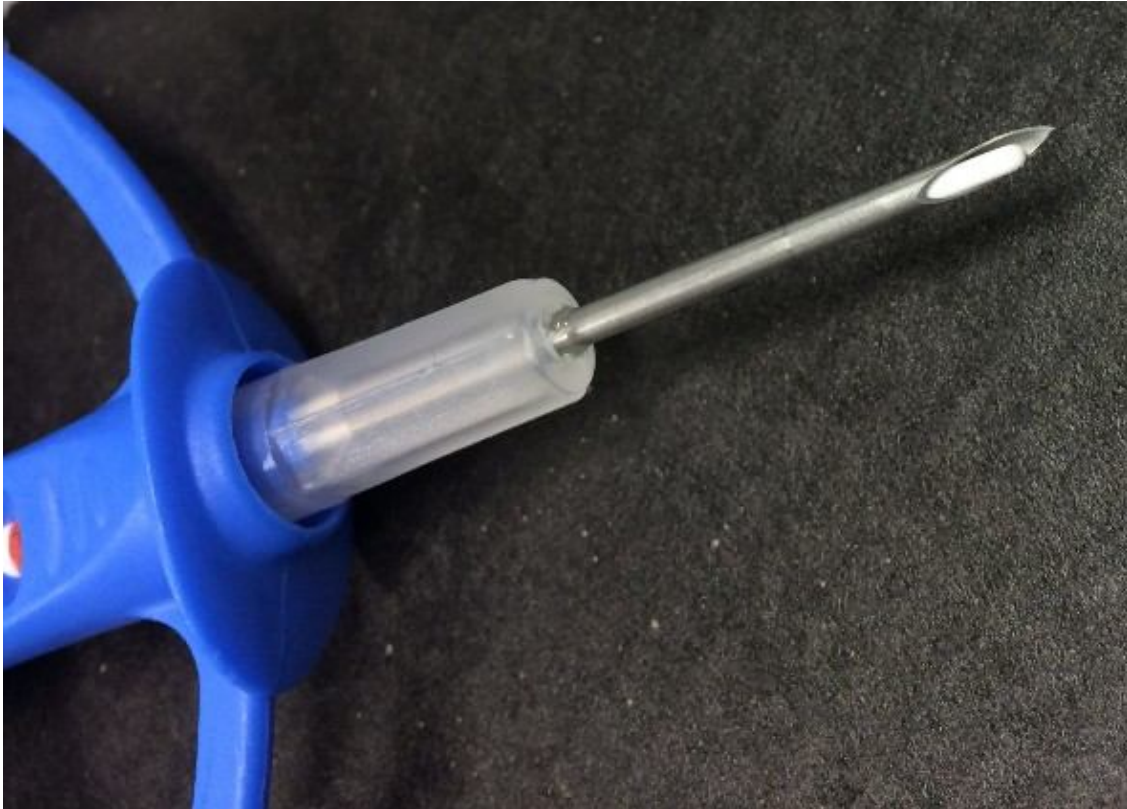
With the cap off we can see that the stylet has passed completely to the tip of the needle to eject the microchip implant. The red line in the indicator window can also be seen.
